4-13-2015

Bracket Modification

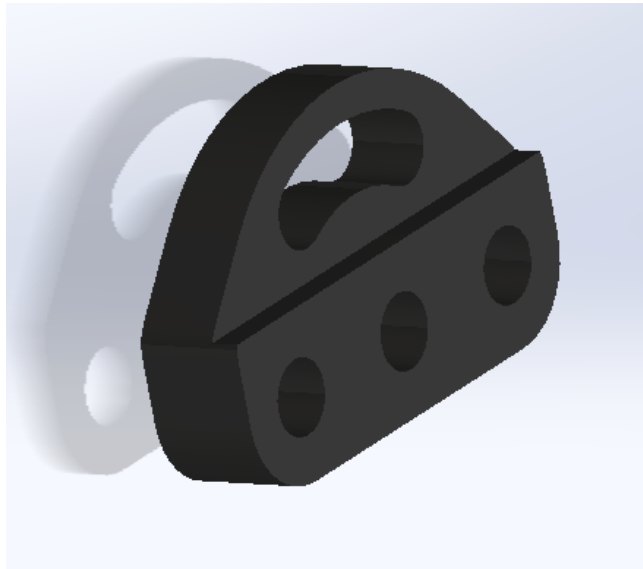
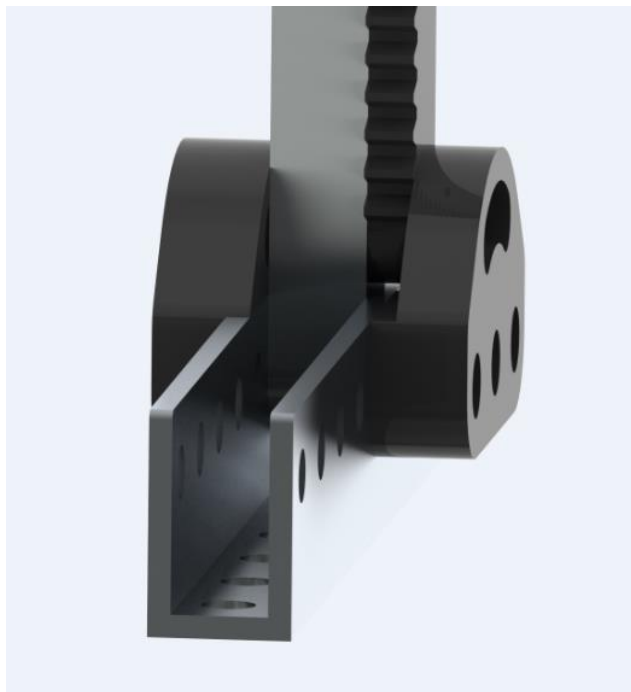
The previous bracket worked well until another design change resulted in the project box hitting the bottom of the bracket. The second slot was not needed (was there for redundancy), and was deleted, with the resulting bracket below:
